NL INDUSTRIES/TARACORP SUPERFUND SITE GROUP
2209 Quarry Drive, Suite C-35
Reading, PA 19609
Telephone: (610) 670-7310
Facsimile: (610) 670-7311

Re: NL Industries/Taracorp Superfund Site; Granite City, Illinois
First 2022 Semi-Annual Operation and Maintenance Inspection (June 28-29, 2022)

**NL Industries/Taracorp Superfund Site
Inspection Log - Operation and Maintenance**

Inspection Date: June 28, 2022

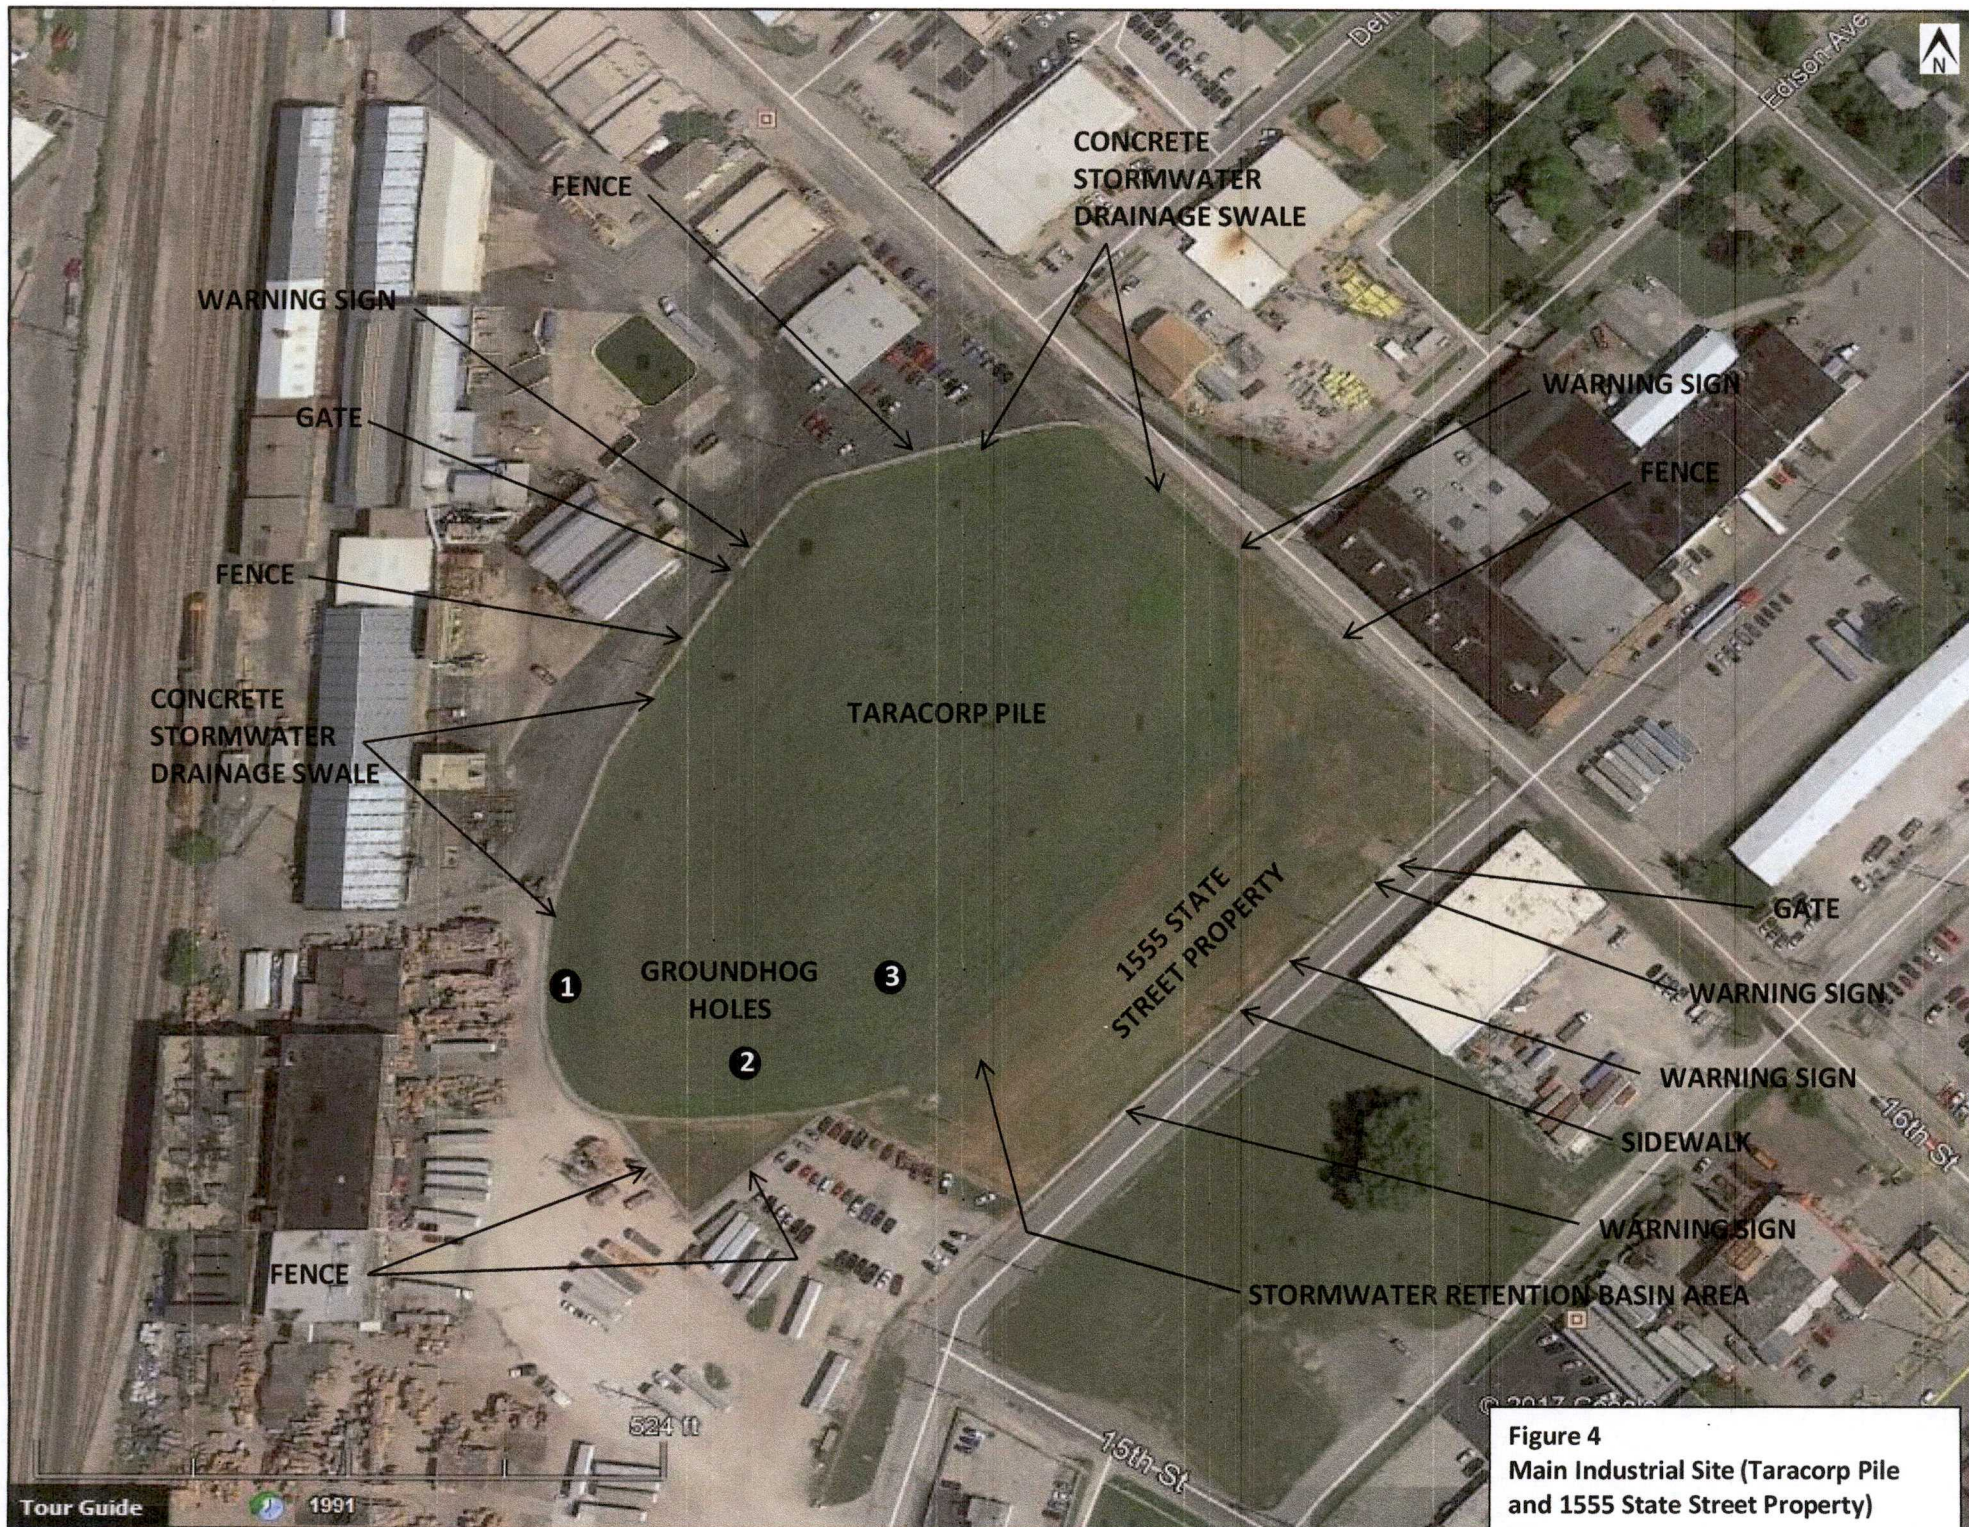
Figure 4
Main Industrial Site (Taracorp Pile
and 1555 State Street Property)

- Based on the results of the inspection, the Group has requested that its contractor, Double D Wildlife Control, return to the main industrial site to trap and remove groundhogs from three sets of holes that were observed in the cap on the southern end of the Taracorp pile at the locations shown on Figure 4 (Attachment 5, photographs 92-94).

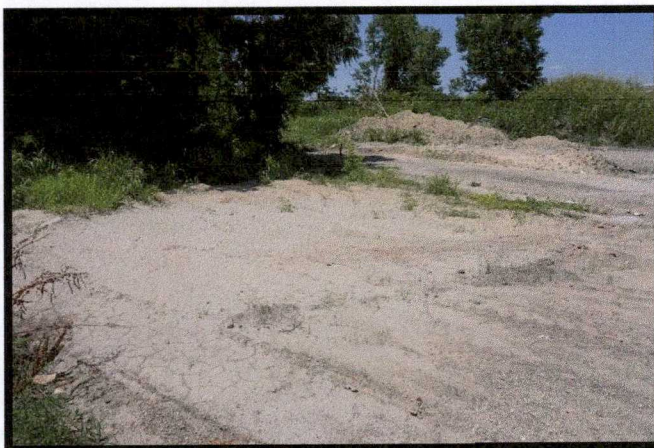
- At Slough Road (shown on Figure 1 and the photographs in Attachment 1), no disturbance of the gravel cover to the previously paved area (Slough Road) was observed. Mr. Earl Boyd, Terminal Manager for Beelman River Terminals, Inc. (Beelman), confirmed that there has been no disturbance to the paved surface of Slough Road (which is no longer visible) since the time the paved roadway was covered with soil/gravel fill as part of the expansion of Beelman's operations. Since the time of the previous inspection, Beelman and/or its contractors have continued to expand Beelman's operational areas by removing soil piles, vegetation, and the concrete foundation of the former Robin's Nest lounge near the south end of Beelman's facility. The area where the foundation of the Robin's Nest lounge was previously located is now covered with crushed stones and gravel (Attachment 1, photographs 10-13).

Photograph 10: Slough Road, former area of concrete foundation of former Robin's Nest lounge.

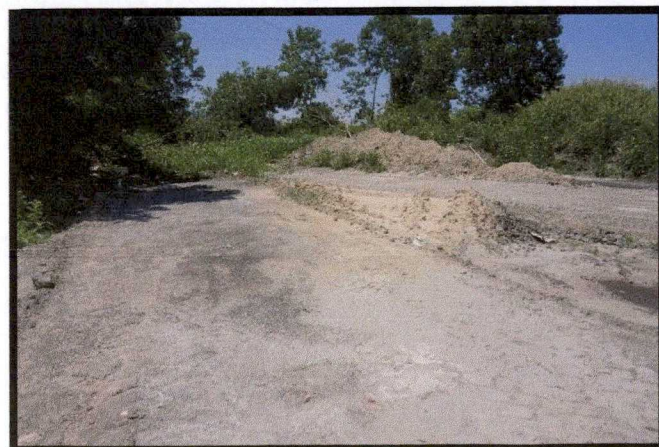
Photograph 11: Slough Road, former area of concrete foundation of former Robin's Nest lounge.

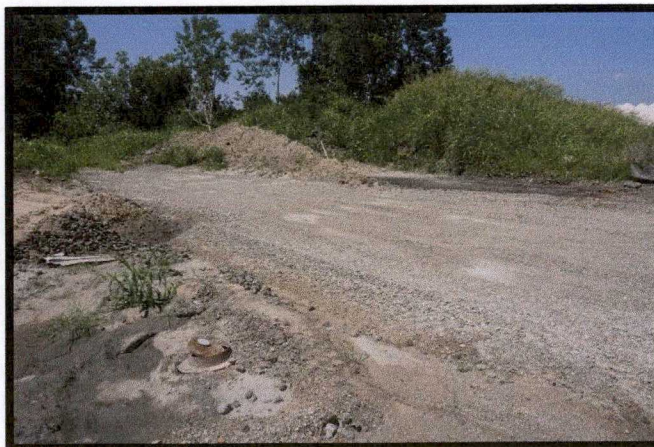
Photograph 12: Slough Road, former area of concrete foundation of former Robin's Nest lounge.

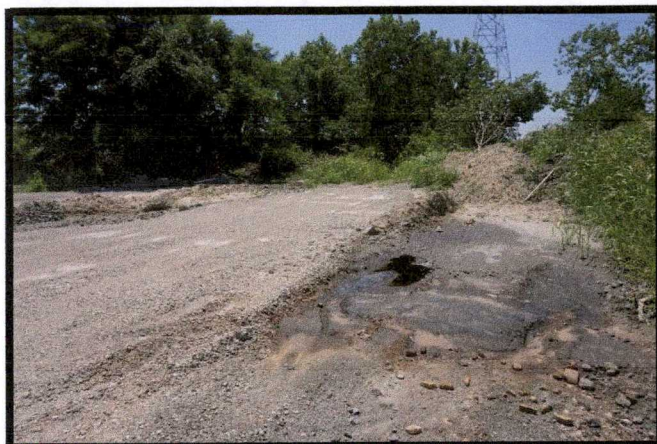
Photograph 13: Slough Road, former area of concrete foundation of former Robin's Nest lounge.

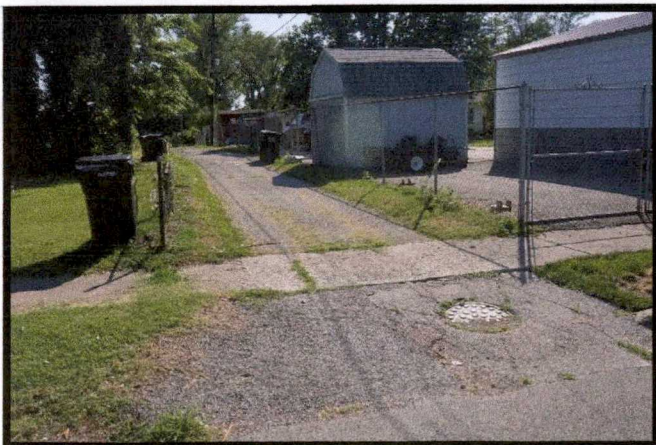
- Alleys in Venice that were paved during remedial activities were noted to be in generally good condition. The Venice alleys are shown on Figure 1 and are identified on the photographs in Attachment 4. Some small asphalt patches were observed (Attachment 4, photographs 16 and 19, for example), confirming that the local municipality is continuing to repair and repave alleys, as necessary.

Photograph 11: EPA Alley 46 (view southwest from 6th Street); repairs at end of alley.

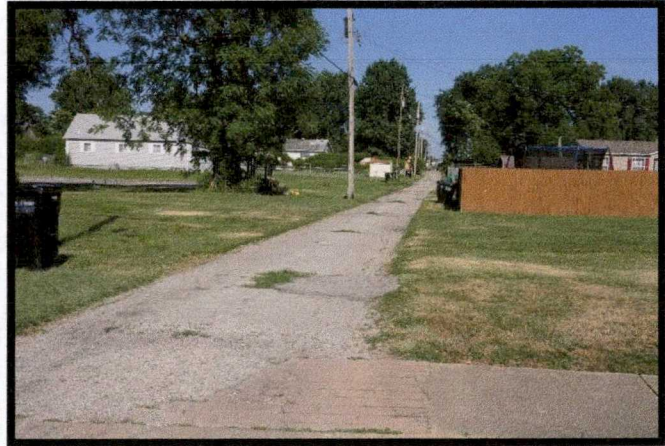
Photograph 16: EPA Alley 10 (view east from Meredocia Street); repairs shown.

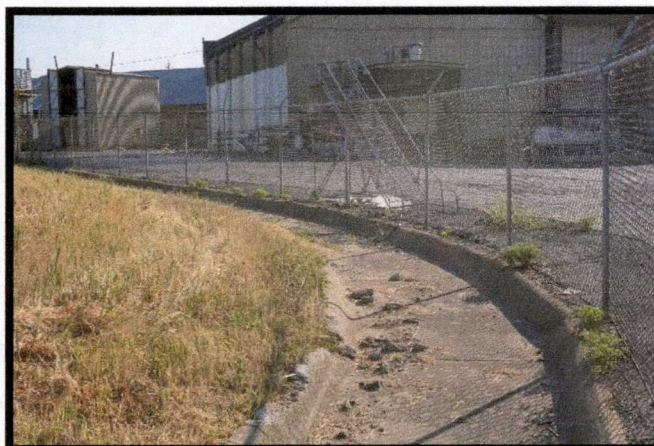
Photograph 16: Concrete drainage swale, crack in concrete along northwestern side of Taracorp pile (view southwest).

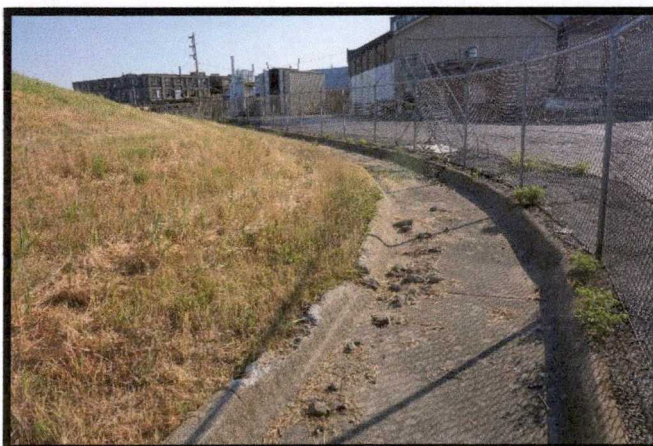
Photograph 17: Concrete drainage swale (cracked concrete), fence, and vegetation along northwestern side of Taracorp pile (view southwest).

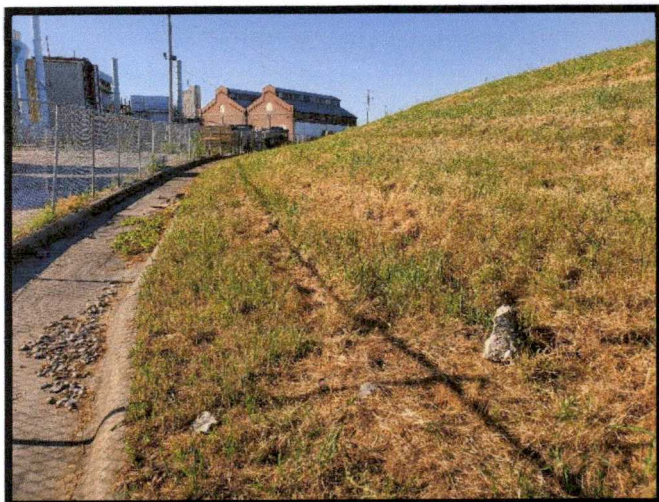
Photograph 92: Groundhog hole 1, marked with rock (view north).

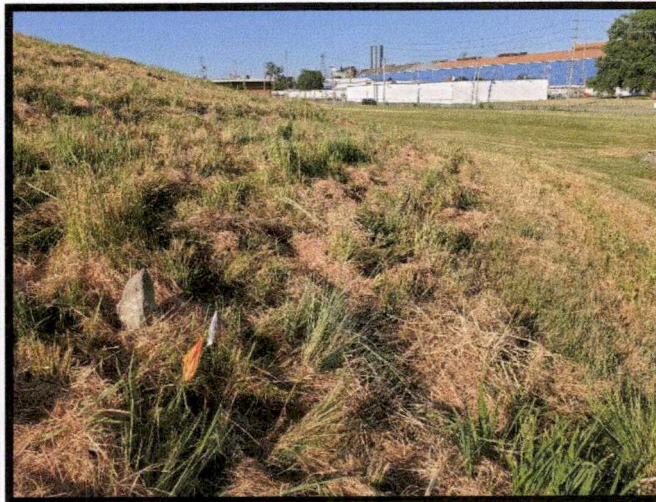
Photograph 93: Groundhog hole 2, marked with rock (view east).

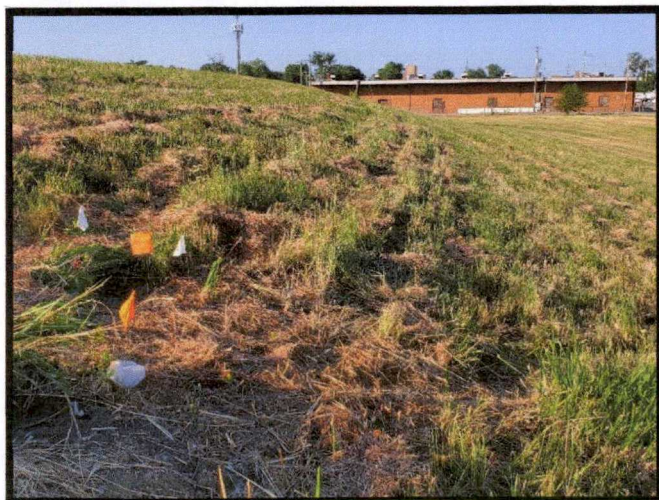
Photograph 94: Groundhog hole 3, marked with flags and plastic (view north).
